NACA RM E57G11

ACCELERATIONS IN FIGHTER-AIRPLANE CRASHES

RESEARCH MEMORANDUM

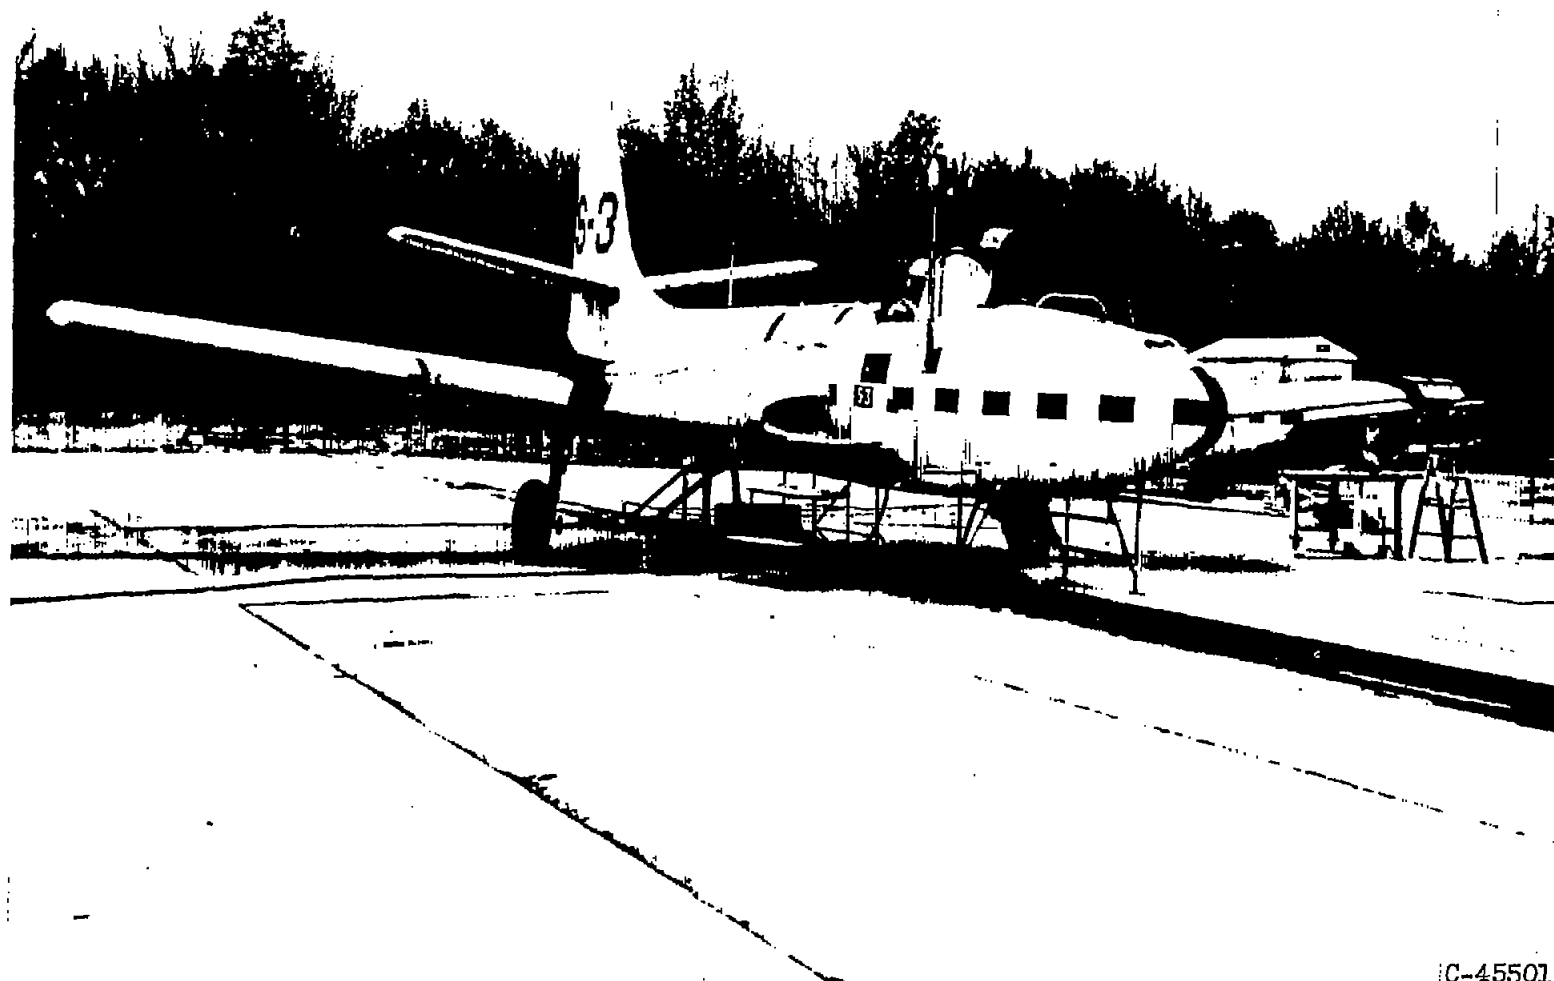
Figure 1. - Airplane used in jet fighter crashes.

The airplanes used for this investigation were single-place, low-wing, twin-engine jet fighters of conventional structure (fig. 1). Both the front and rear spars of the center wing panel continued through the fuselage. The cockpit zone was formed by solid front and rear bulkheads connected by four rigid longerons which extended forward from the wing spars. The bulkhead, at the rear of the cockpit, was a solid, heavy aluminum plate which also served as armor plate. The cockpit floor ahead of the seat was a rather dense structure fastened to the two lower longerons. The floor under the pilot's seat was of light-gage sheet metal. The nose of the fuselage, ahead of the cockpit, was of low-density structure that collapses under low load. The belly of the fuselage, below the cockpit floor, was of a similar construction.

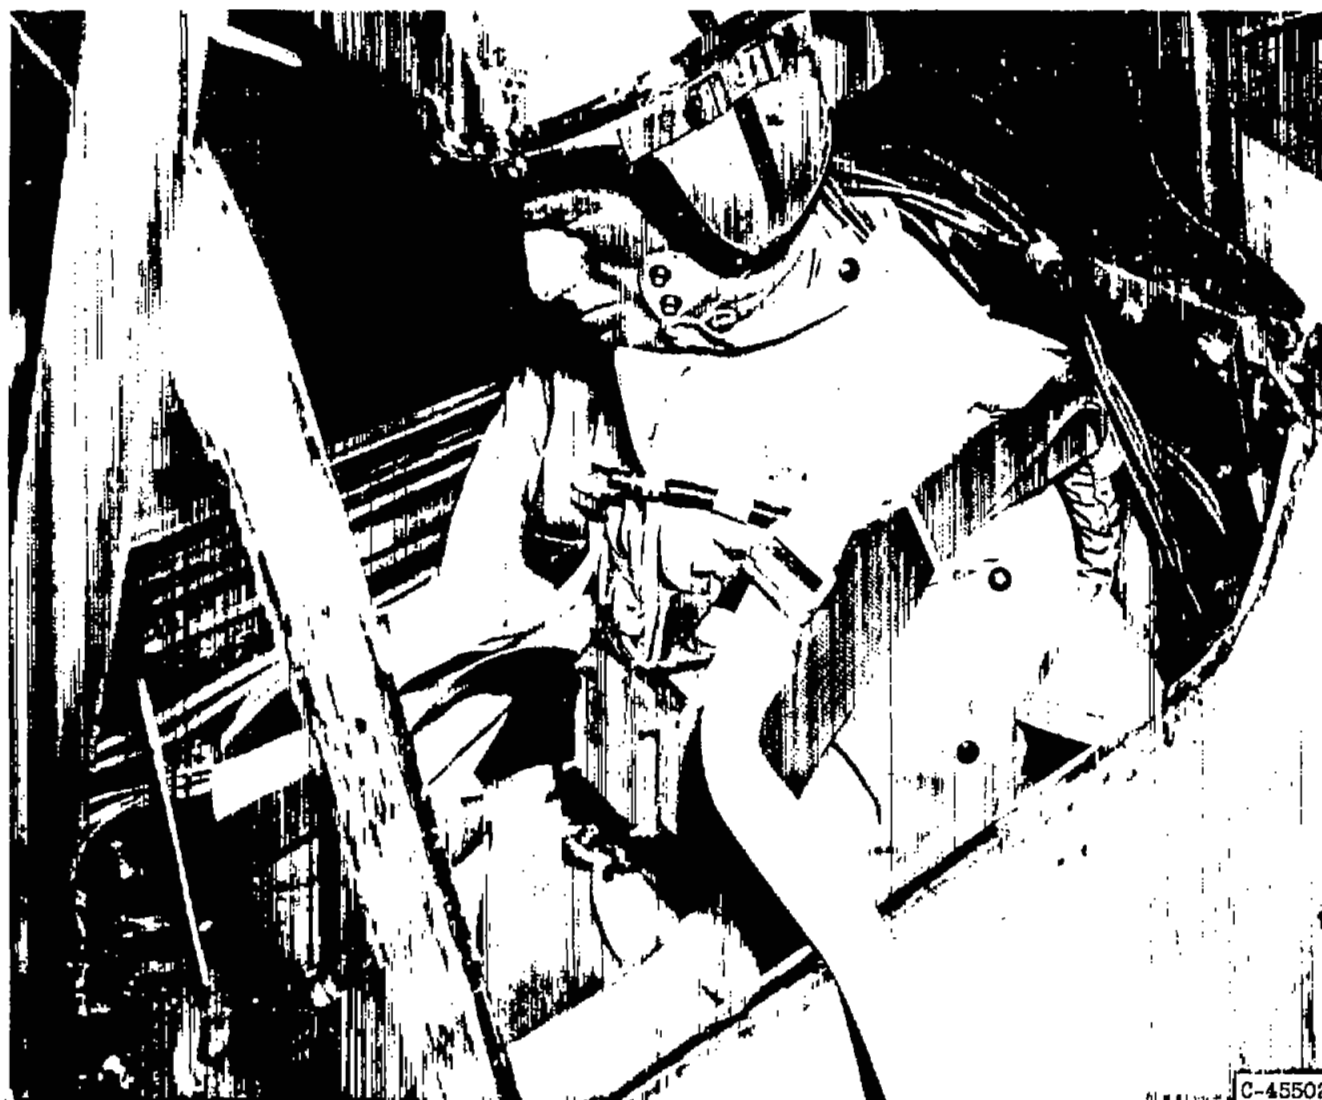
Figure 3. - Anthropomorphic dummy installed in cockpit of fighter airplane.

The dummy was equipped with a Mae West, seat-pack parachute, and helmet. Figure 3 shows the dummy installed in the cockpit.

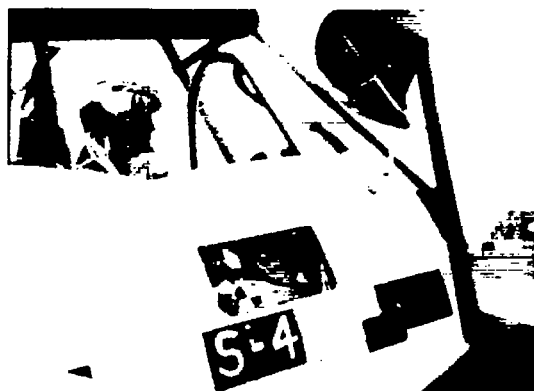
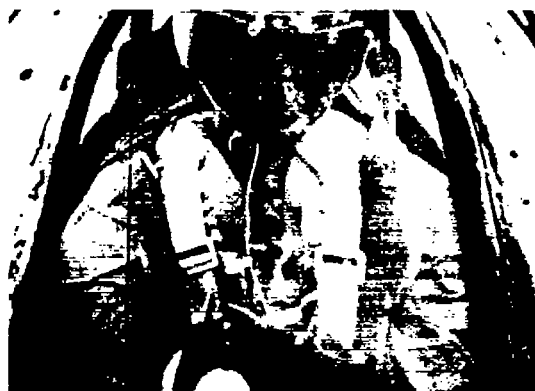
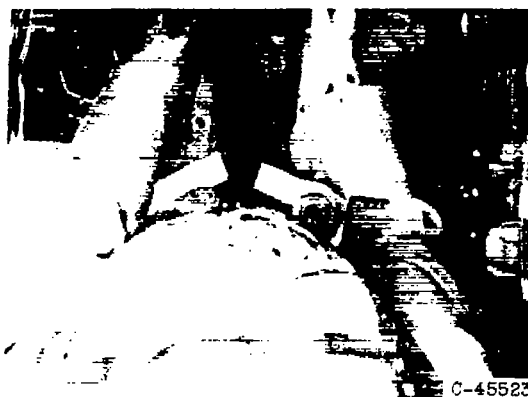
Figure 6. - Sample photographs from airplane cameras of dummy in airplane.

Motion-picture cameras located on the various camera platforms around the crash area and on the airplane recorded the action of the airplane and the dummy throughout the crash. The cameras on the airplane gave closeup motion pictures of the dummy's action. These cameras were installed on the wing and in front of and above the cockpit as shown in figures 5(a), (b), and (c), respectively. A section of the cockpit skin between two longerons was removed to expose the dummy's hip area to the wing-mounted camera. Sample frames of the film from these airplane cameras (fig. 6) show the area of interest covered by each camera.

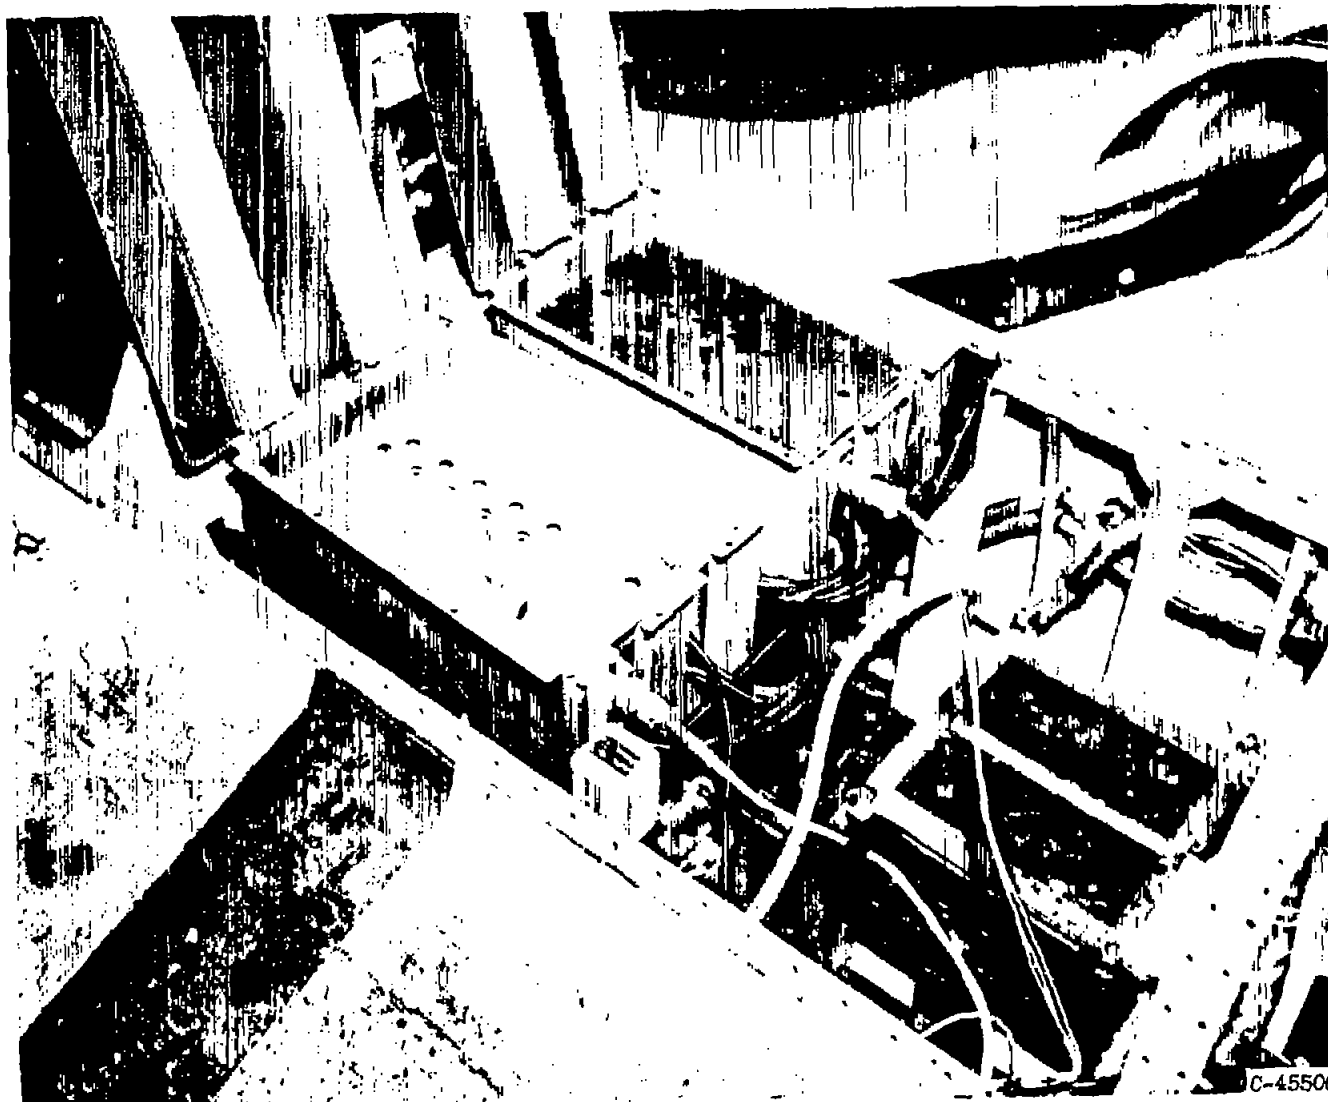
Figure 7. - Telemeter transmitter installed in airplane.

The general location of the telemeter transmitter in the airplane is shown in figure 7. The receiving and recording station located in the operations building (ref. 4) is shown in figure 8.

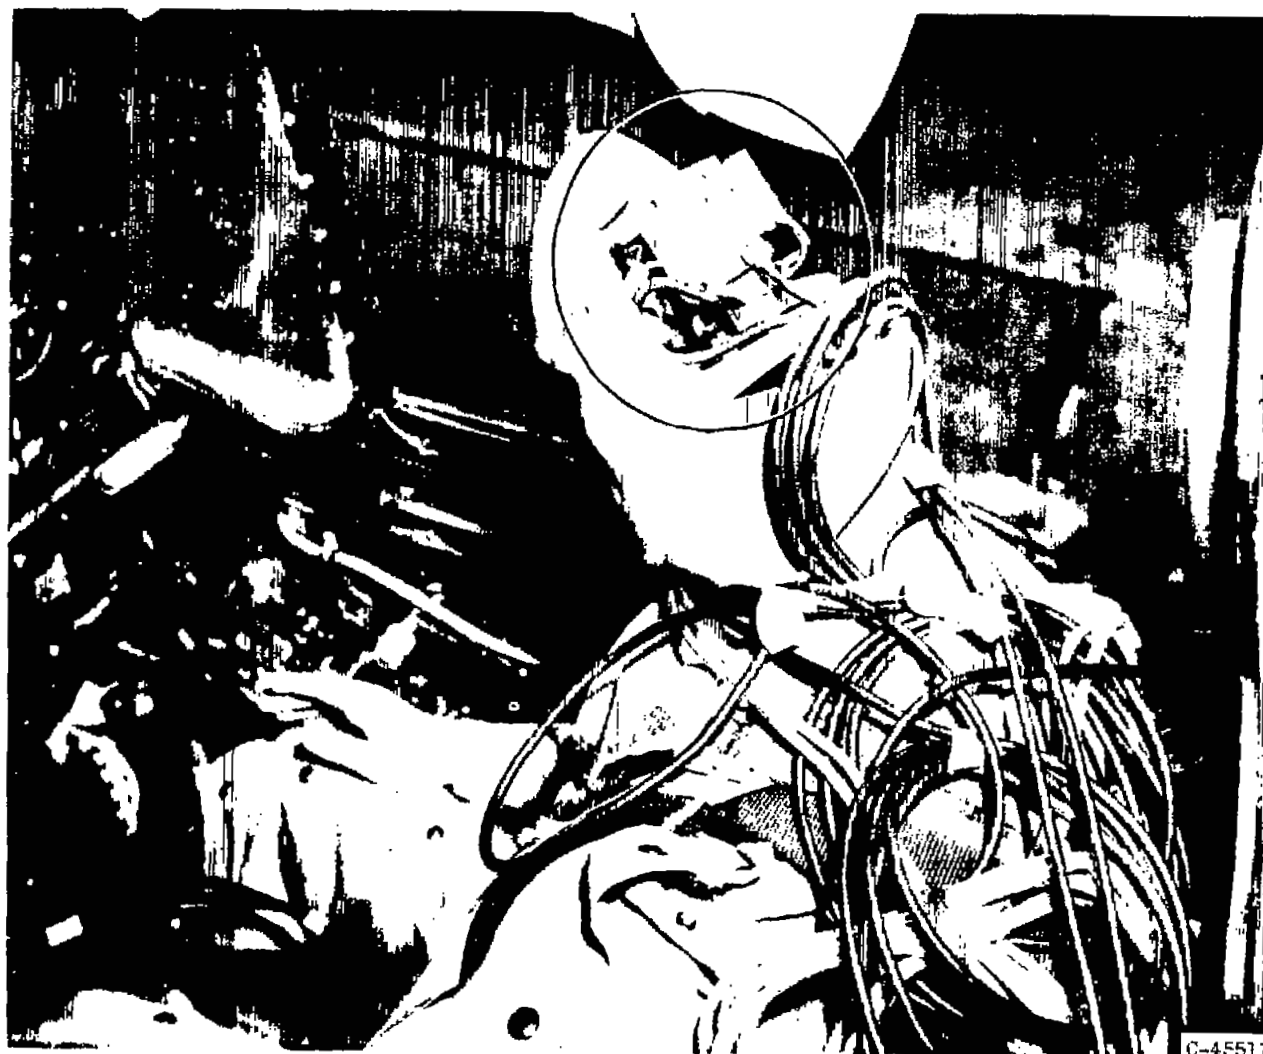
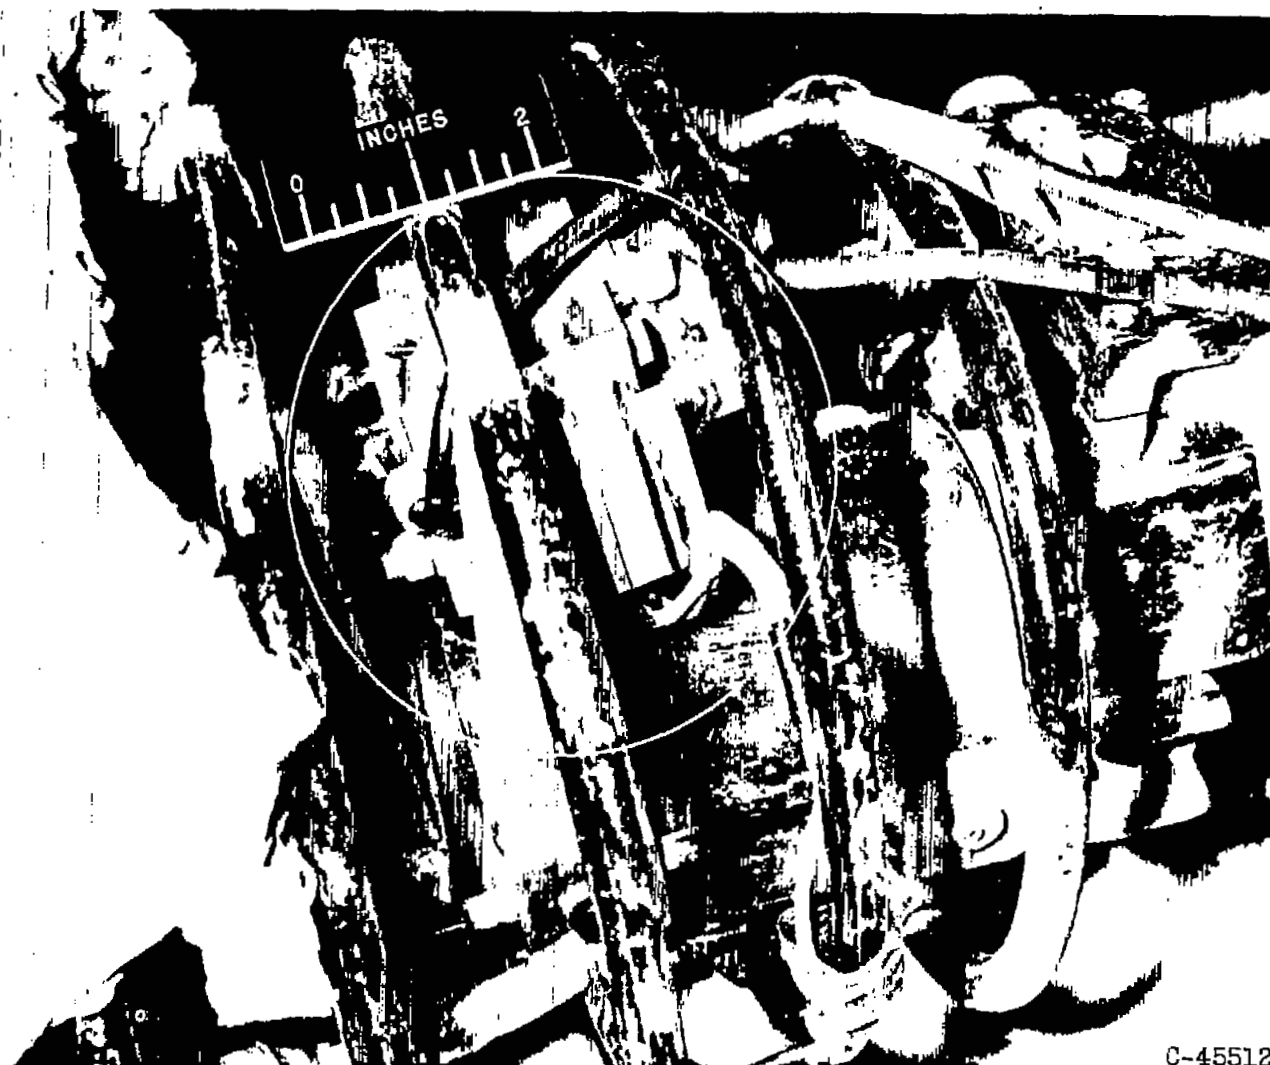
(a) Head.

Figure 10. - Accelerometers installed in anthropomorphic dummy.

(b) Chest.

(c) Hips.

The accelerometers were mounted on machined steel blocks which were installed at various locations on the airplane and dummy. The specific location of each accelerometer as installed in the airplane and dummy is shown in figures 9 and 10 and is listed in the following table:

Accelerometer location	Direction of acceleration			Figure
	Longi- tudinal	Ver- tical	Lat- eral	
Airplane floor (cockpit)	x	x	x	9(a)
Airplane bulkhead	x		x	9(b)
Airplane center of gravity	x	x	x	9(c)
Seat pan (cockpit)		x		
Dummy's head	x	x	x	10(a)
Dummy's chest	x	x	x	10(b)
Dummy's hips	x	x	x	10(c)

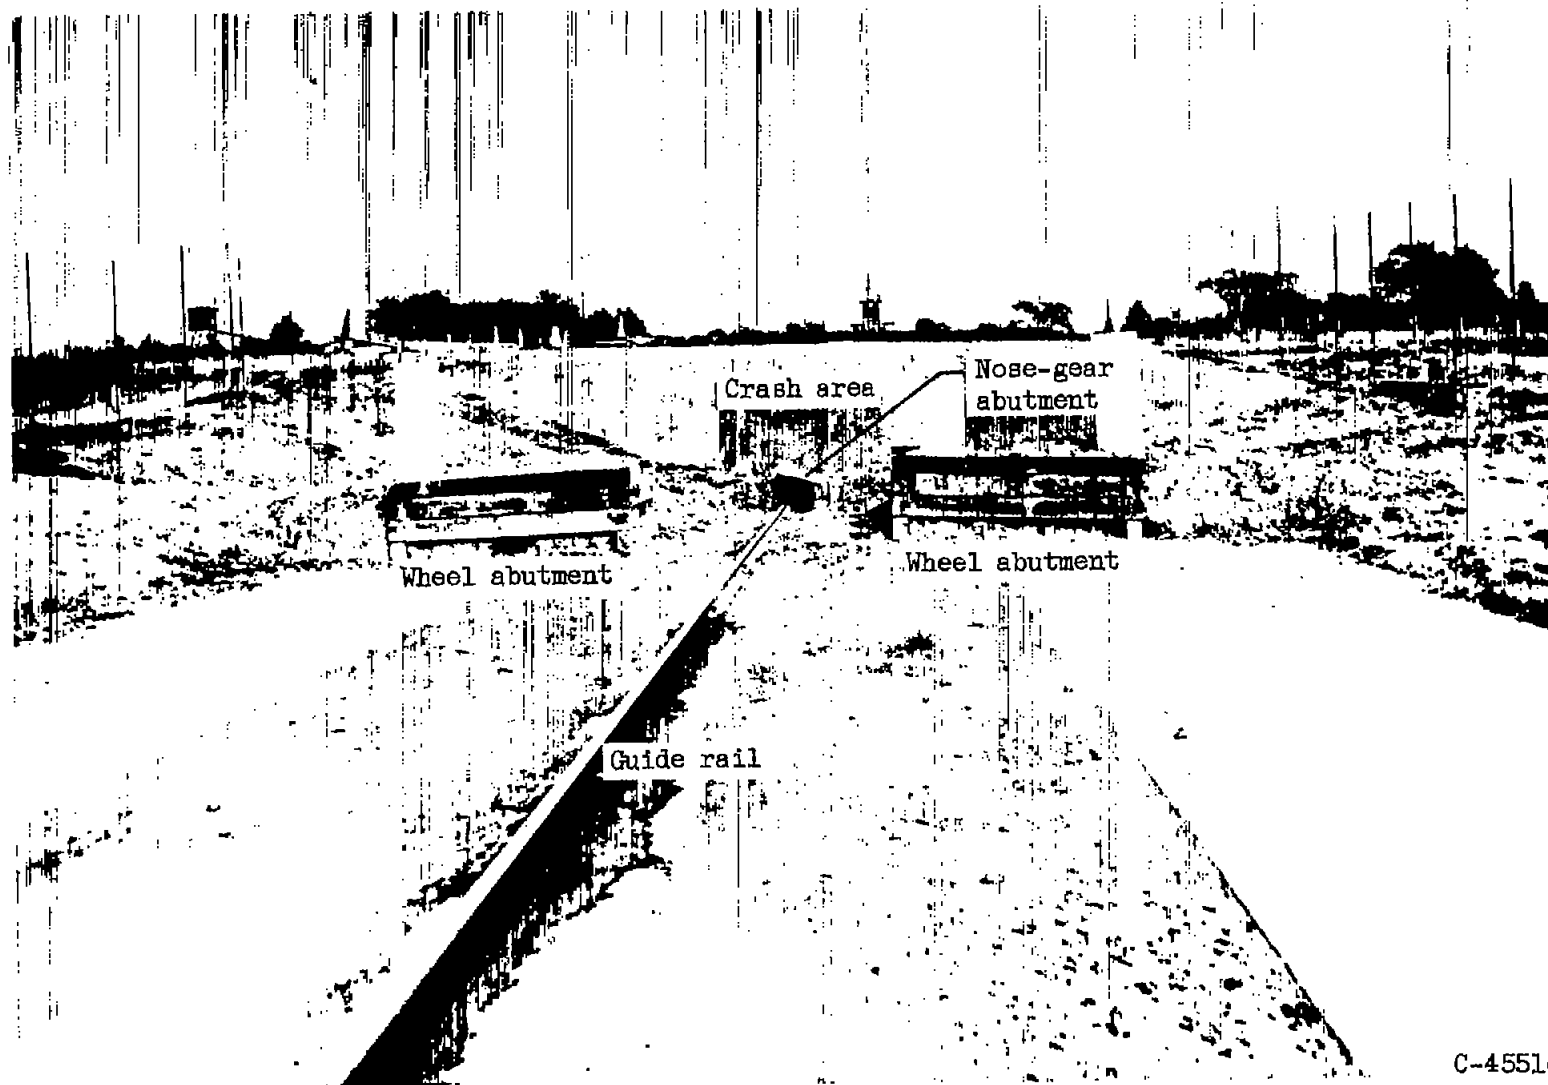
Figure 13. - Crash area used for unflared landing crashes showing wheel and nose-gear abutments.

Description of unflared landing crashes. - In the three unflared landing crashes, both main landing-gear assemblies were ripped from the airplane by wheel abutments. The abutments that tore off the main landing-gear wheels and the abutment that tore off the nose-gear assembly are shown in figure 13. The latter abutment was set at an angle of  $10^\circ$  to the longitudinal axis of the airplane to deflect the nose gear to one side and avoid impact with the underside of the airplane. In this way, damage to the dummy and the instrumentation by the nose gear was prevented. After the airplane passed through these barriers, it

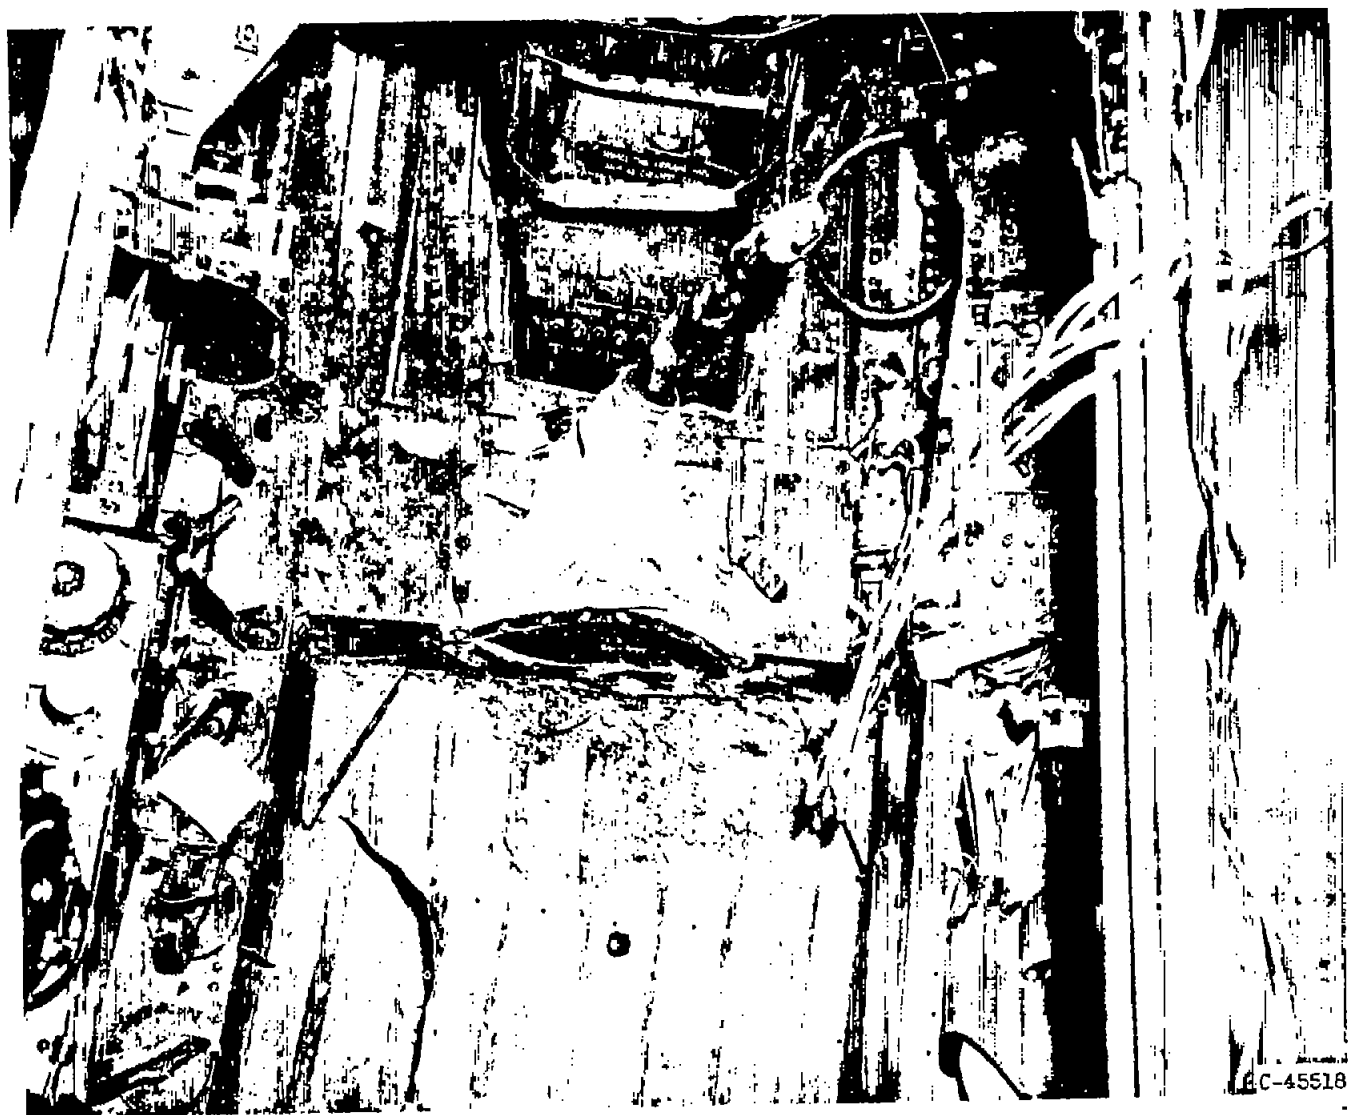
Figure 18. - Cockpit of jet fighter after 22<sup>0</sup> unflared landing crash.

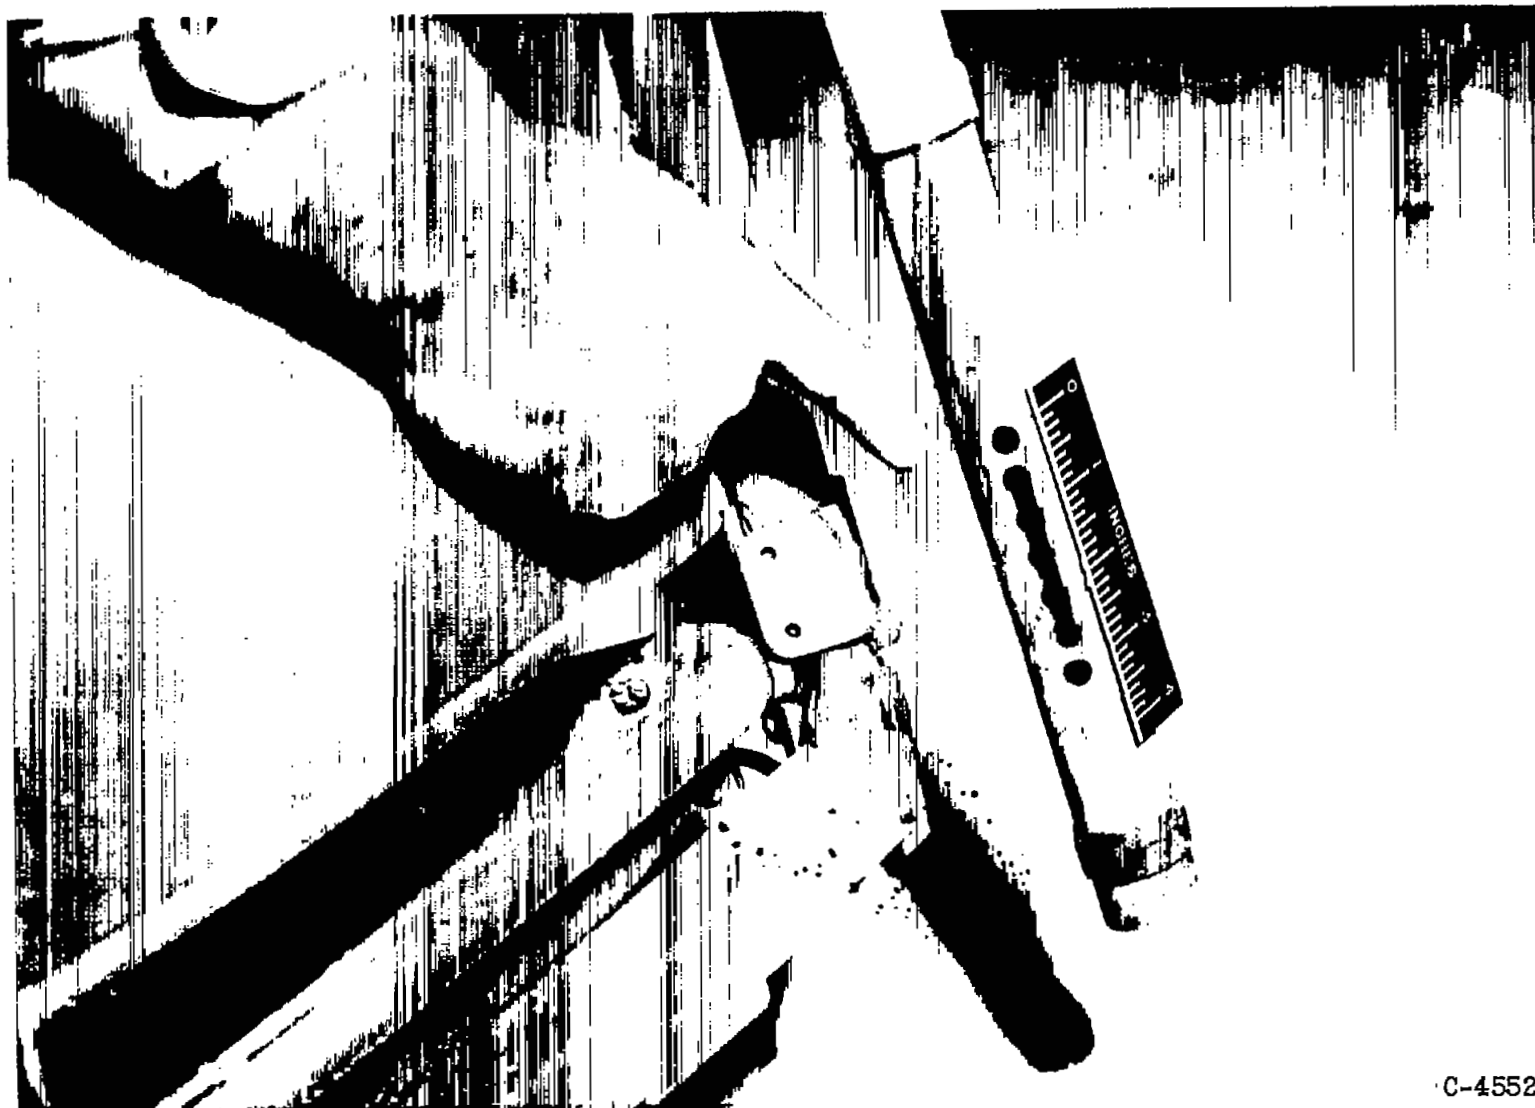
Figure 39. - Holes sheared in seat support tube during 22° unflared landing crash of fighter airplane.
